PRELIMINARY ASSESSMENT (PA)

METRUM FACILITY LITTLETON, COLORADO

**Metrum Facility Site
Littleton, Colorado**

**U.S. EPA Contract No. 68-W9-0053
Work Assignment No. 18-8JZZ**

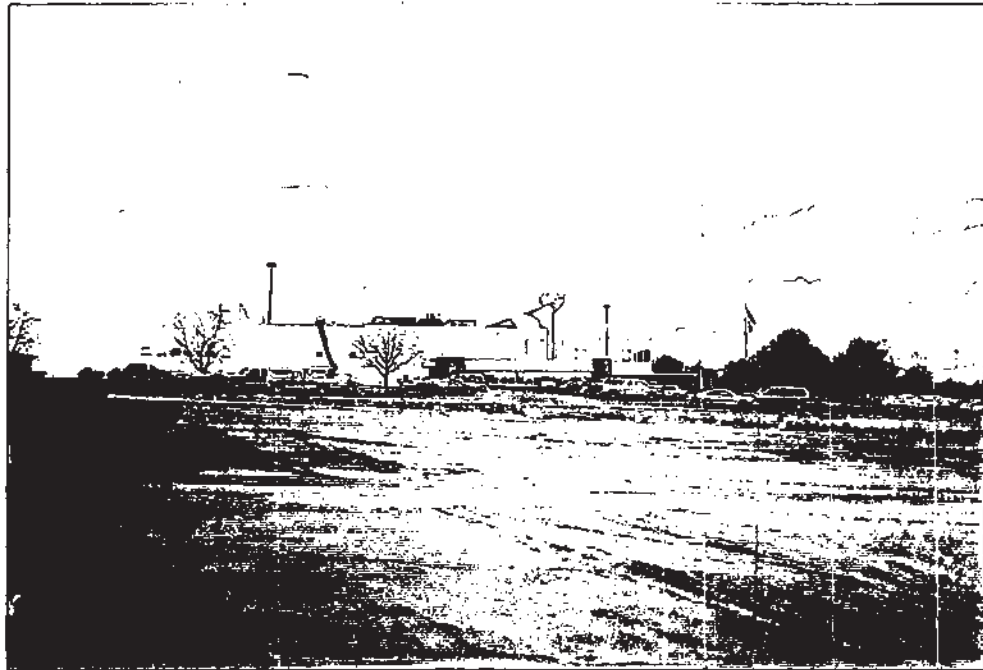
PHOTO 1

The Metrum facility looking west. The exposed soil area in the foreground is the location of a future residential development.

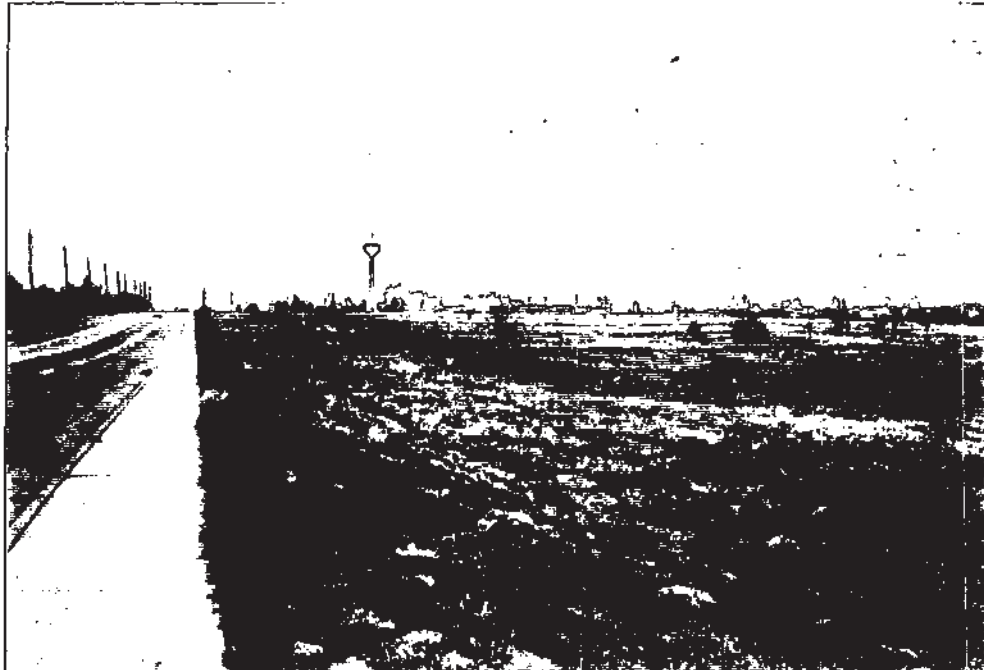
PHOTO 3

Looking southeast at the site (background) from Dry Creek Road (to the left). Undeveloped land borders the site on the west (foreground).
